Cracks in onshore wind power foundations

Causes and consequences

Elforsk rapport 11:56

January 2012

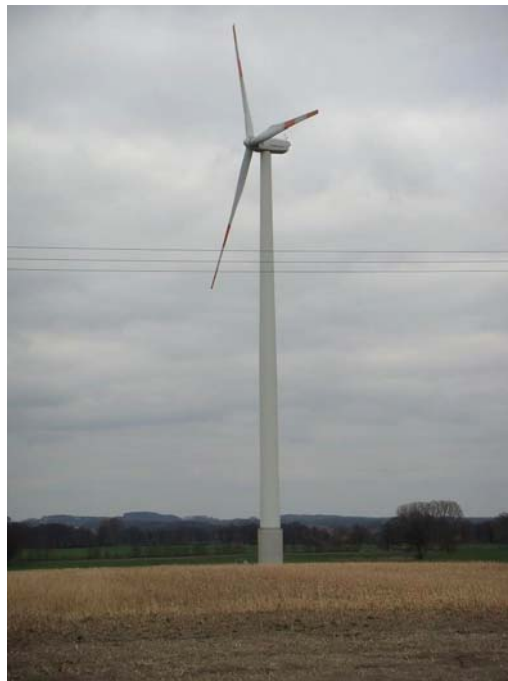
Figure 2 – Tubular steel tower on reinforced concrete pedestal.

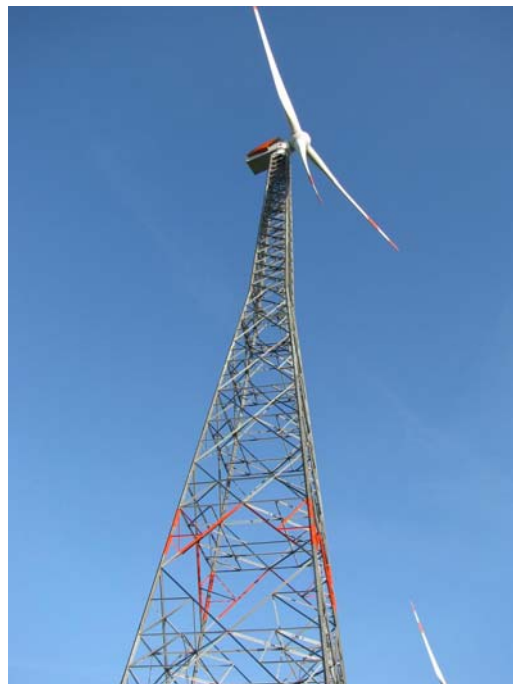
Figure 3 - Lattice tower.

Maintenance is one of the major drawbacks of the lattice system. There are many joint bolts in a lattice tower, 10,000 in some case. Each bolt must be inspected three times during its service life, which is 20 years. The additional drawbacks of the lattice towers are associated with the towers stiffness and natural frequency. Although the problems can be remedied by increasing the number and the thickness of the elements, profiles, etc the problem can't be solved without increasing the size of the tower's cross-section. However, increased cross-sectional area leads to wider area in the base of the tower, i.e. wider foundation is needed. Furthermore, there are limits for the size of the cross-section at the higher levels. At the higher levels the position of the rotor is a decisive factor, i.e. the distance between the rotor and the tower must be sufficiently large in order to avoid a collision between the rotor and the tower.

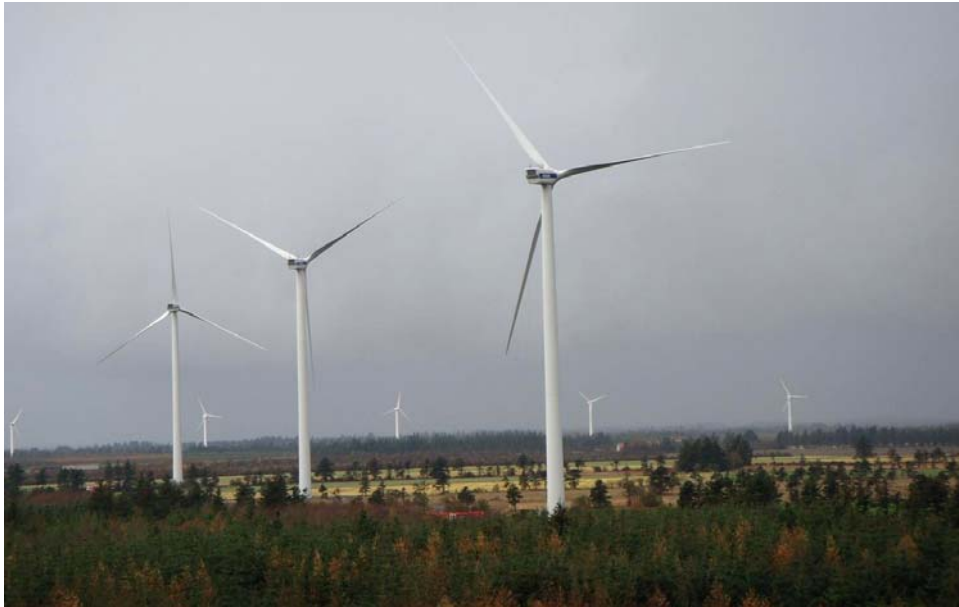
Figure 5 – Towers made of prestressed cast-in-place and slipform cast concrete.

All concrete towers are made of reinforced concrete. Functionally two types of reinforcements are used, namely non-stressed (ordinary cast in reinforcement) and post-tensioned reinforcement. The first one is used to provide bearing capacity during production and erection of the tower while the latter is used to place the concrete cross-section in a state of compression before application of service loads. The advantages of the concrete towers are their stiffness, robustness and maintenance properties. A properly designed and produced concrete tower does not need any maintenance during the designed service life. Furthermore, concrete towers in a distant location may be easier and cheaper to produce than the steel towers.

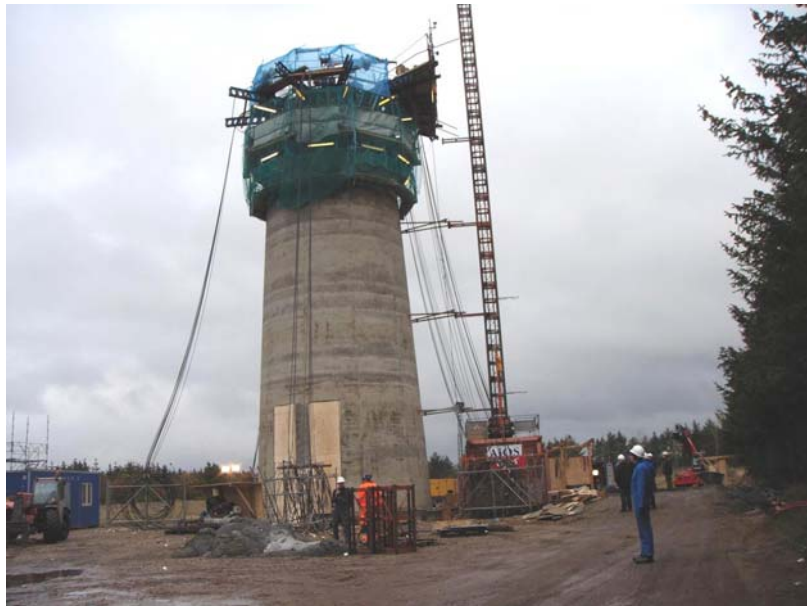
Figure 6 – Production of prestressed cast-in-place and slipform cast concrete.

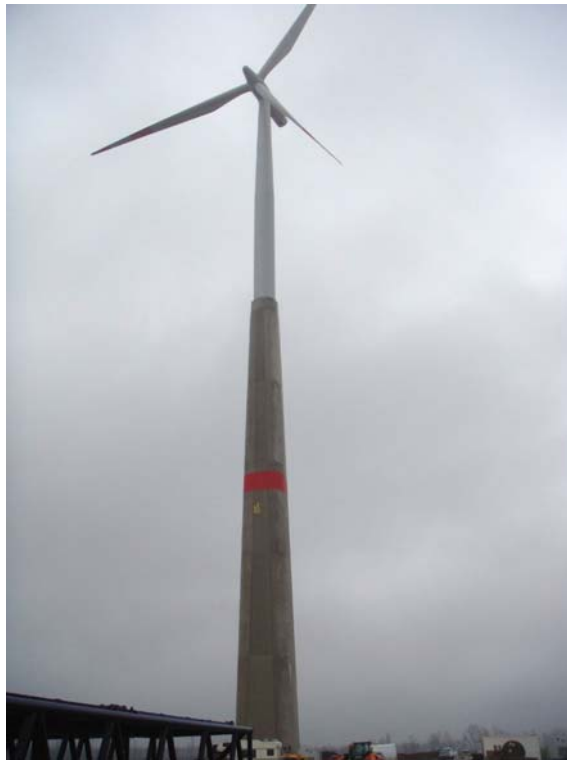
Figure 7 – Hybrid concrete and tubular steel tower.

The structural concepts and the production techniques which are used for the concrete part of the hybrid concrete and steel towers are with a few exceptions similar to those of the concrete towers.

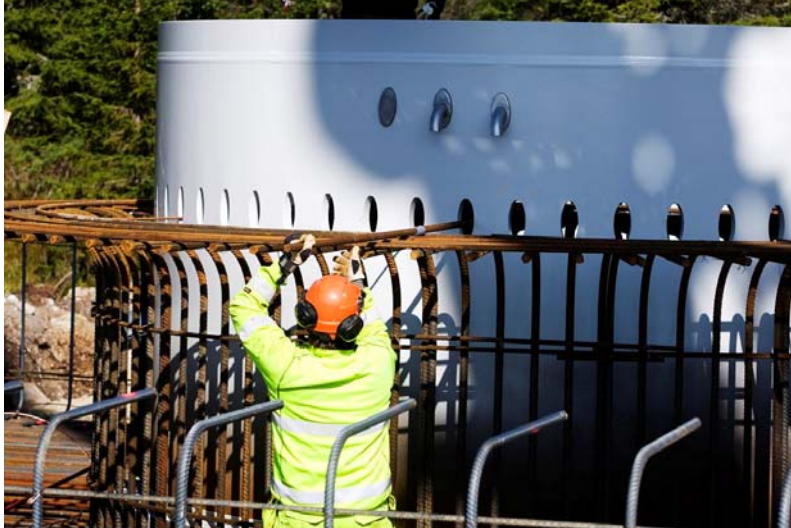
Figure 14 – Insert ring with holes through which the reinforcement bars pass.

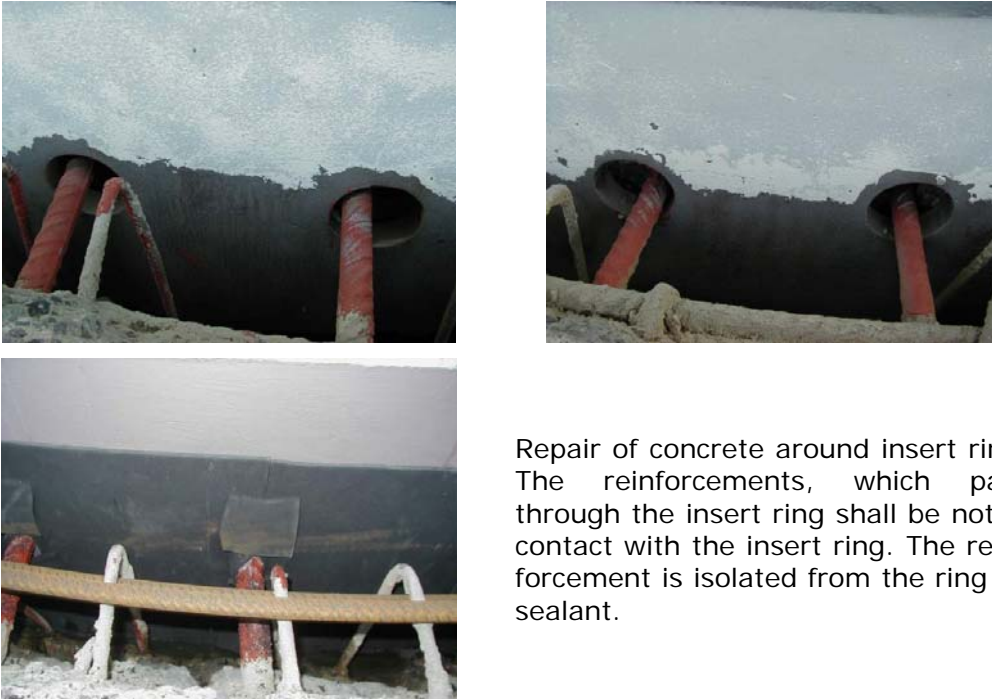
Repair of concrete around insert ring. The reinforcements, which pass through the insert ring shall be not in contact with the insert ring. The reinforcement is isolated from the ring by sealant.

Figure 16 – Repair of concrete around insert ring, [9].

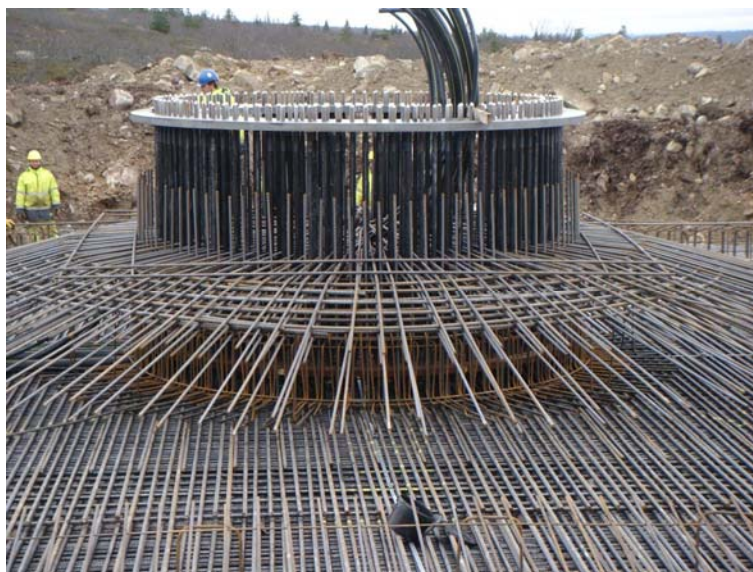
Figure 21 – Flange on the top of the pedestal before casting.

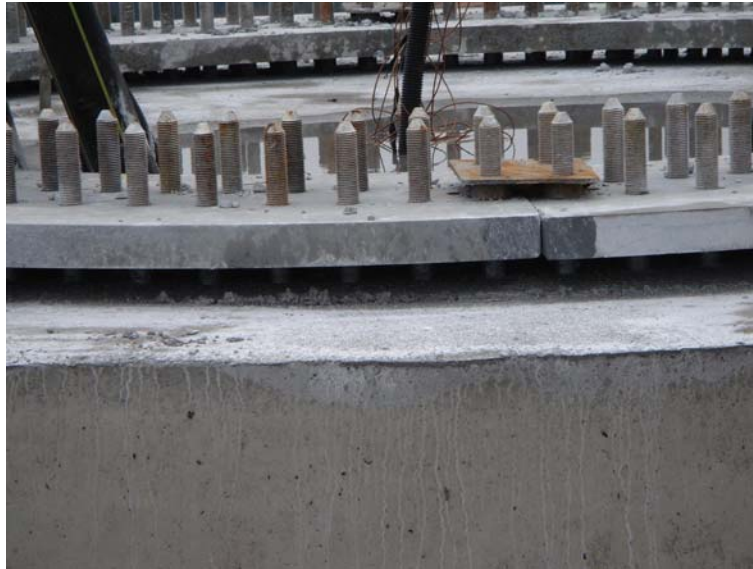
Figure 22 – Flange on the top of the pedestal after casting.

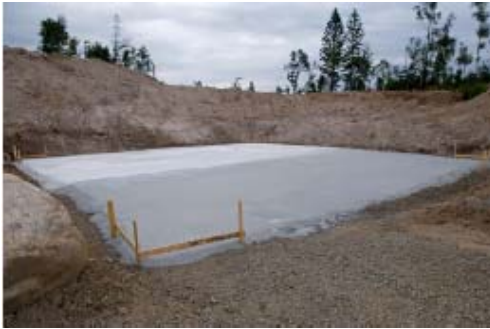
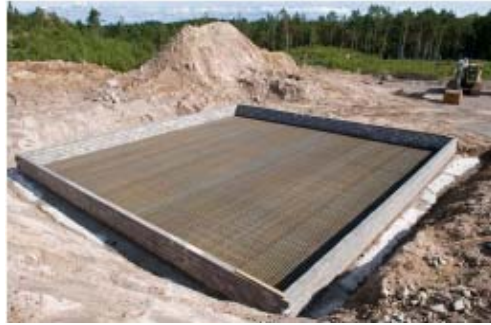
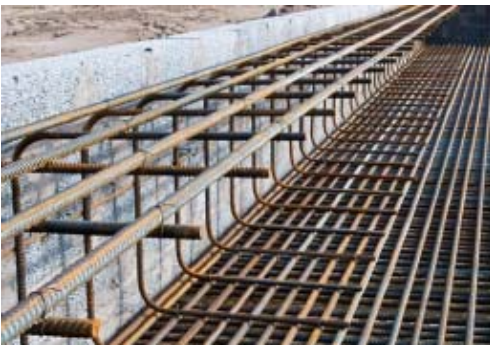
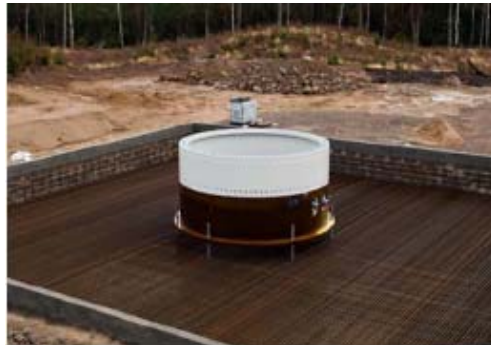
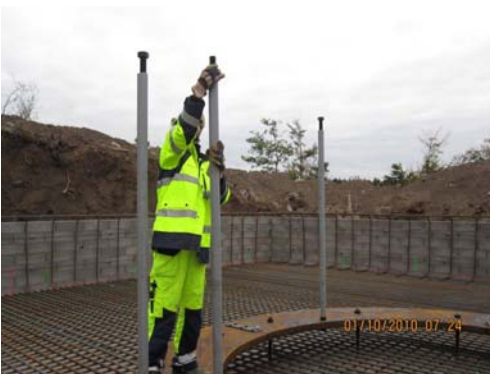
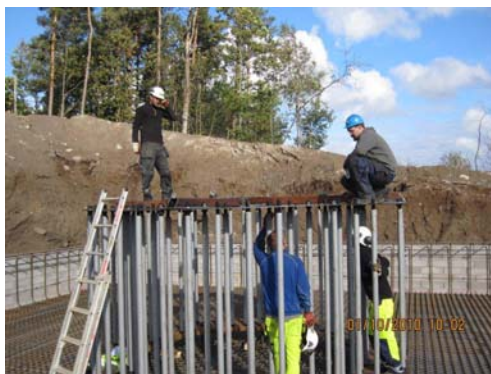
1- Bottom concrete layer

2- Bottom reinforcement

3- Bottom and edge reinforcement

4- Insert ring

5- Stud bolts and bottom ring

6- Stud bolts and upper ring

Figure 23 – Different production steps, 1-4 [12] and 5-6 [10].

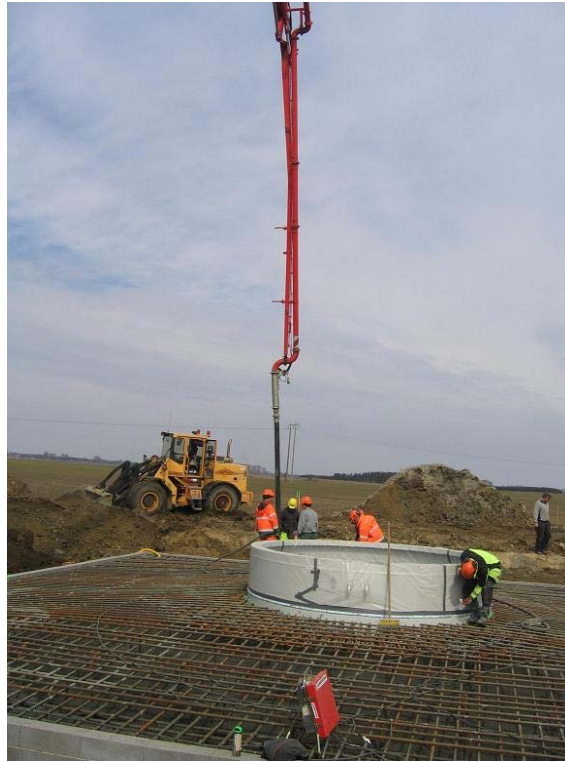
Figure 24 – Pouring of concrete in a prepared spread footing formwork, [13].

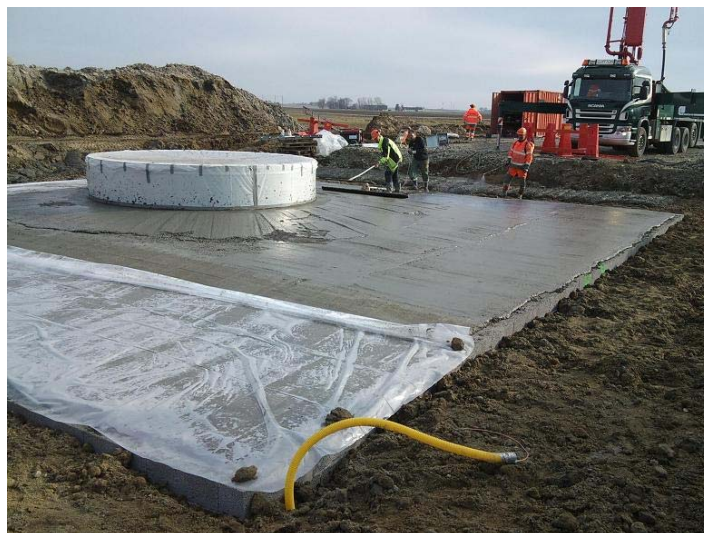
Figure 25 – Trowelling of the surface and covering the surface by plastic foil to prevent drying during curing, [13].

Foundation surface is sloped to drain the water from the surface. The slope is achieved by pouring more concrete in the central part of the foundation and then smooth down the surface towards the edges, Figure 25.

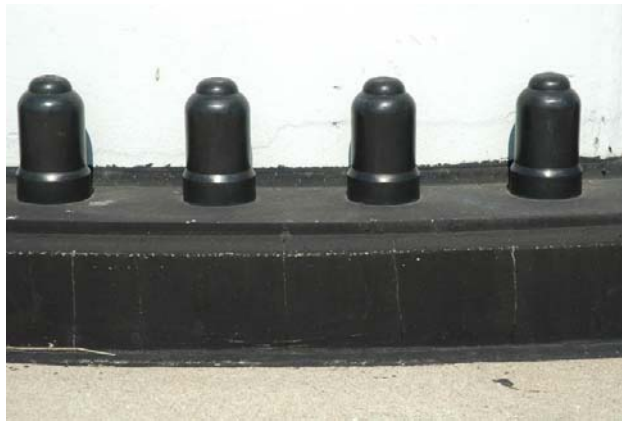
Figure 28 - Vertical shrinkage cracks, [15].

The first two problems are actually harmless. However, the two other problems require some remedial actions to be taken, which may necessitate the replacement of the mortar grout.

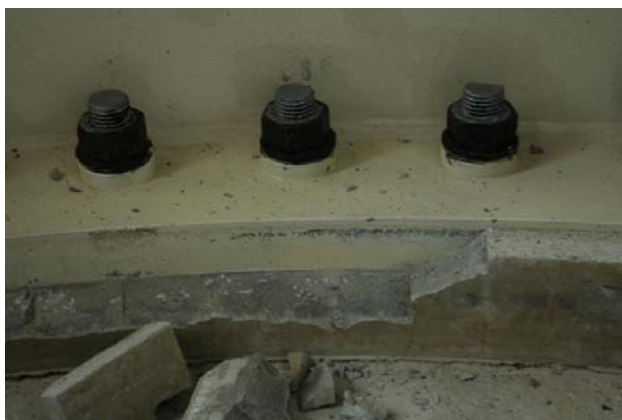
Figure 29 - Side excess material, [15].

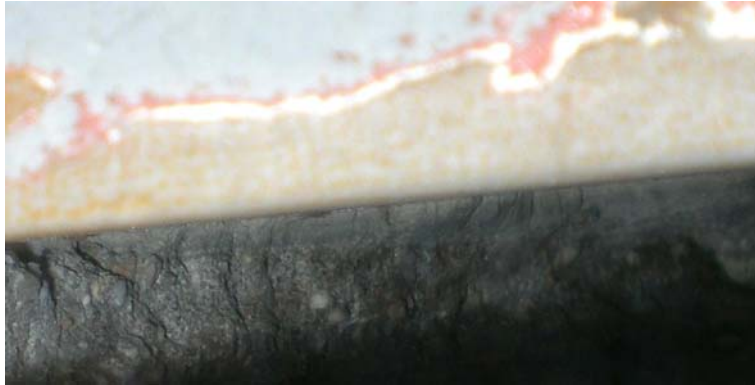
Figure 30 – Weak mortar grout caused by separation of the mortar, [9].

Some other damages associated with the defect mortar grout are reported by [9], for instance: soft layer due to separation in mortar, air inclusion inside the mortar and below the flange and non-uniform grouting material.

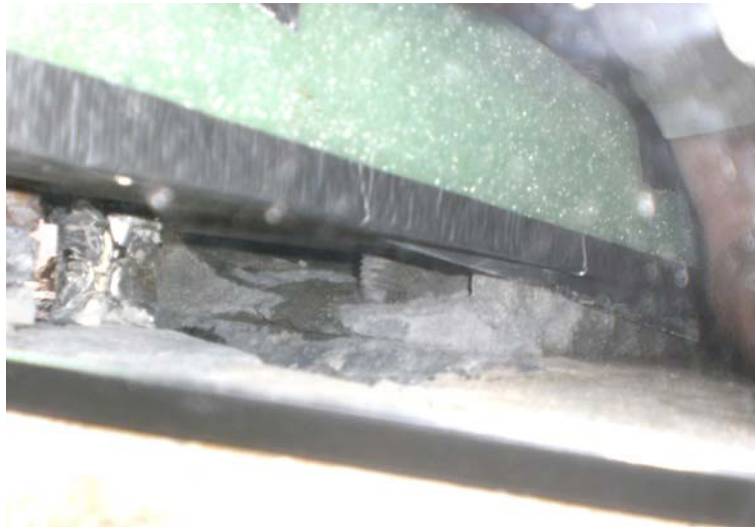
Figure 31 – Inclusion of air voids inside the mortar grout under the flange, [9].

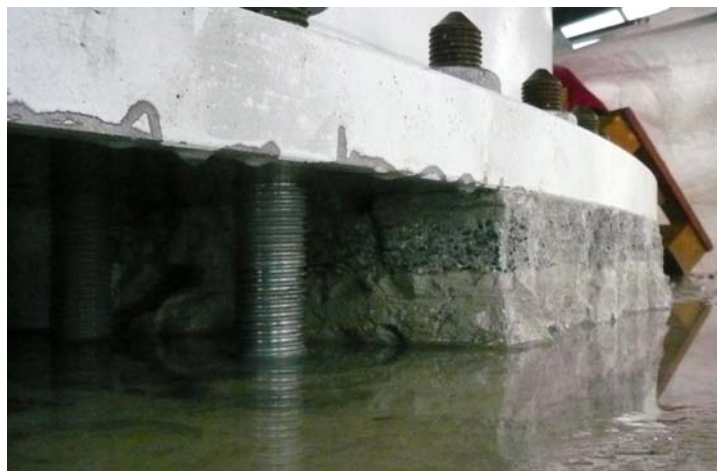
Figure 32 – Two different mortar grouts are used, [9].

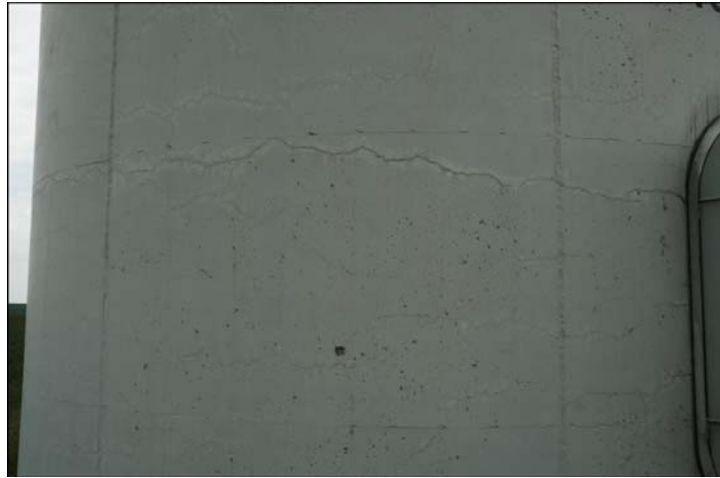
Figure 33 - Cracks in the reinforced door area, [15].

A foundation type which is used, mainly in Germany, to achieve a significant increase in the hub height, and energy production, was steel towers mounted on the foundation pedestal [15]. The solution was a circular pedestal of about 4 to 8 m height on the existing foundation. The wall thickness of the pedestal was approximately 1 m in order to have enough space for the bolts or wires for mounting of the steel tower. The steel tower can be mounted either by wires or by the pre-stressed anchor bolts. This type of structure shows many cracks, which generally are horizontal. The crack widths are not negligible, where as many of them are even larger than 0,4 mm.

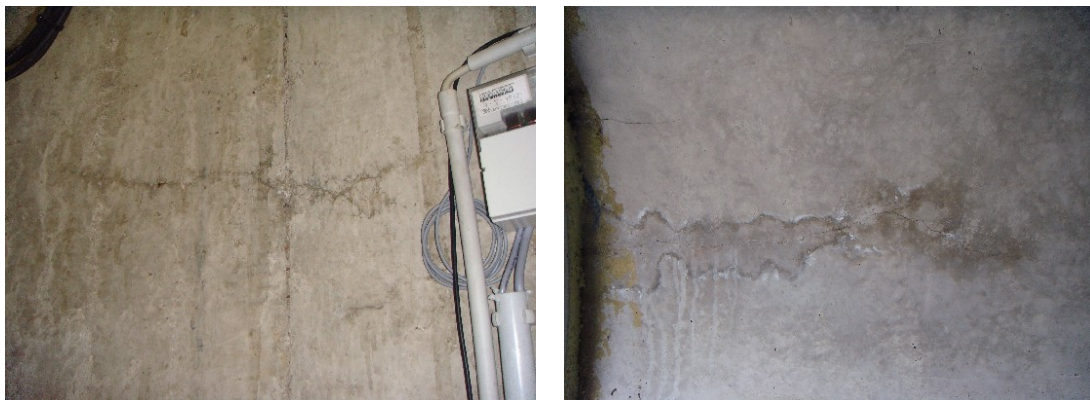
Figure 34 – Cracks on the concrete pedestal inside the structure, photo Hasanzadeh 2011.

It has been observed that the cracks go through the structure. As the Figure 34 shows the crack leads in water and dirt from the outside to the inside of the structure.

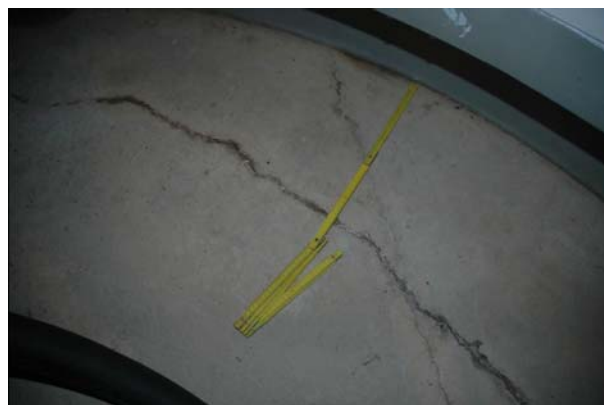
Figure 39 – Significant crack approximately 35 cm from the tower, [15].

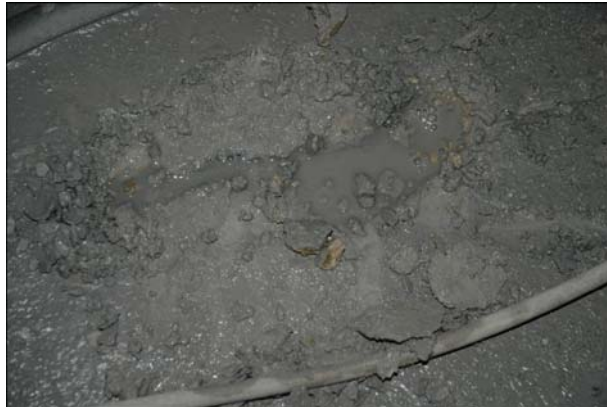
Figure 40 - Spalling (s) due to the cracks, with out-flowing water, [15].

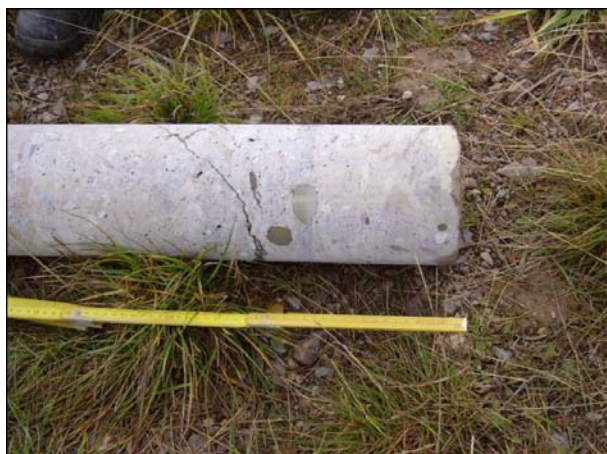
Figure 42 - Crack approximately 30 cm from the bottom of the foundation, [15].

The foundations of two wind power turbines were core-drilled. The drilling was carried out through the height of the foundations. As it was feared the punching cracks, as described above, were observed at the bottom of the foundation, Figure 42.

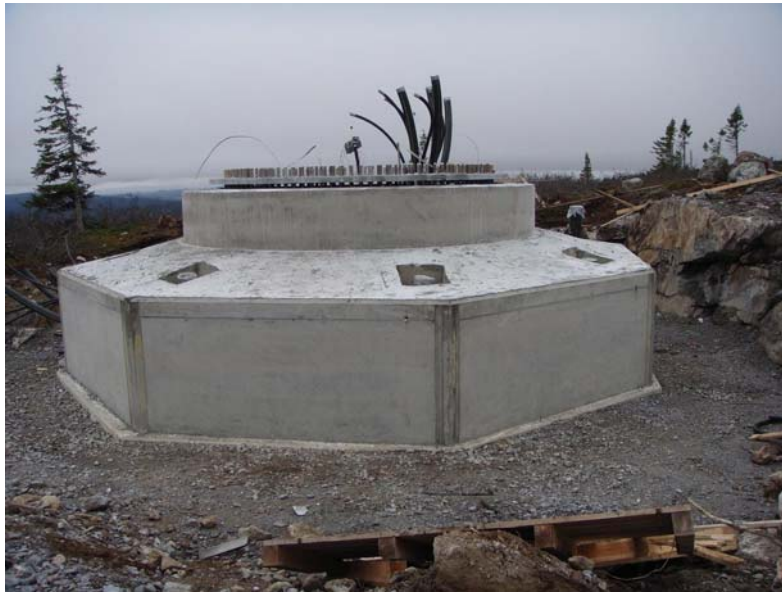
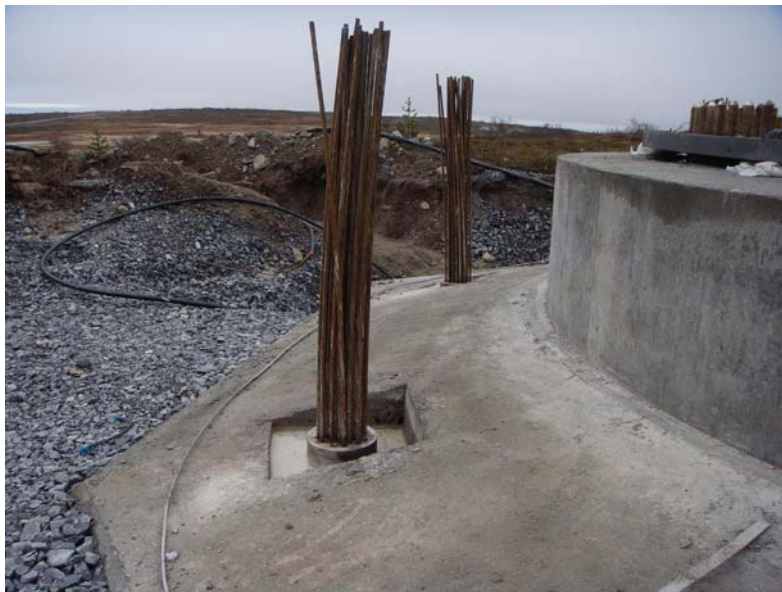
Figure 1 – Footing founded on the bedrock. The footing is anchored to the bedrock. Please notice the load spreading plate which is anchored by the stud bolts. The tower flange will be mounted on the plate. Please also notice that the photos do not refer to the same object. However, the objects are in the same site and principally identical.

Appendix 5 shows an example of a foundation on bedrock.

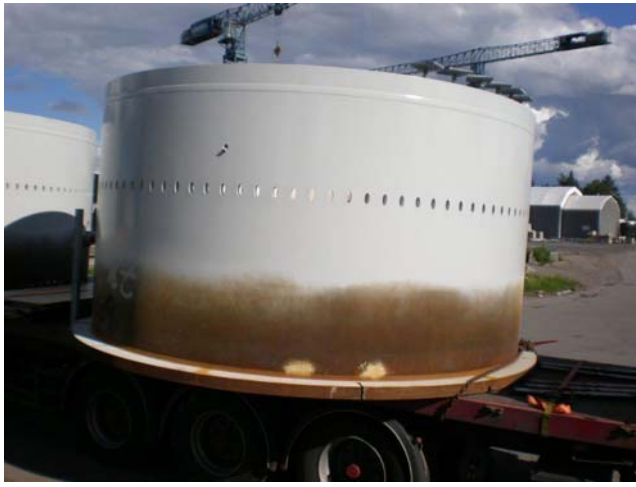
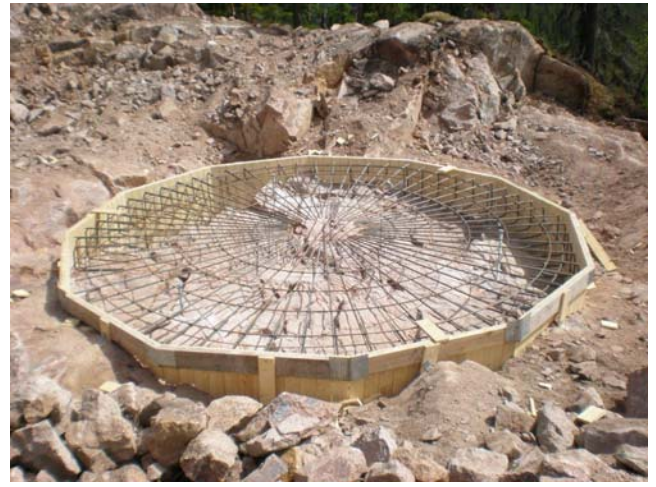
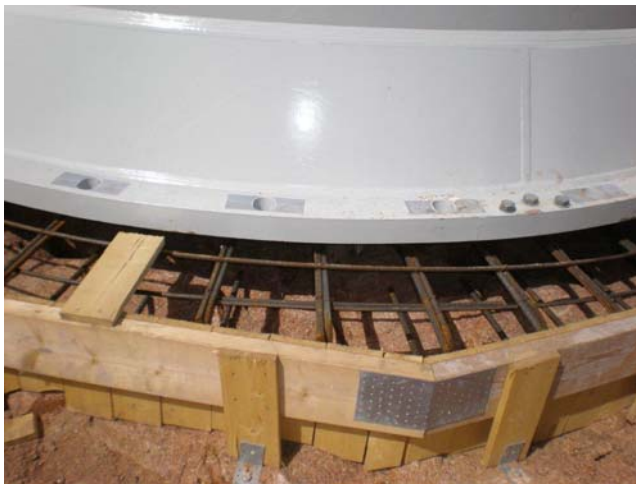
Figure 2 – Insert rings are also used for foundations on the bedrock.
